Acceptance Testing - GE Signa Excite Echosped 1.5T Scanner

Location: Perth Royal Infirmary, NHS Tayside

Radiation Physics Acceptance  
Summary Report

Summary of Acceptance Testing 19th—20th December 2003

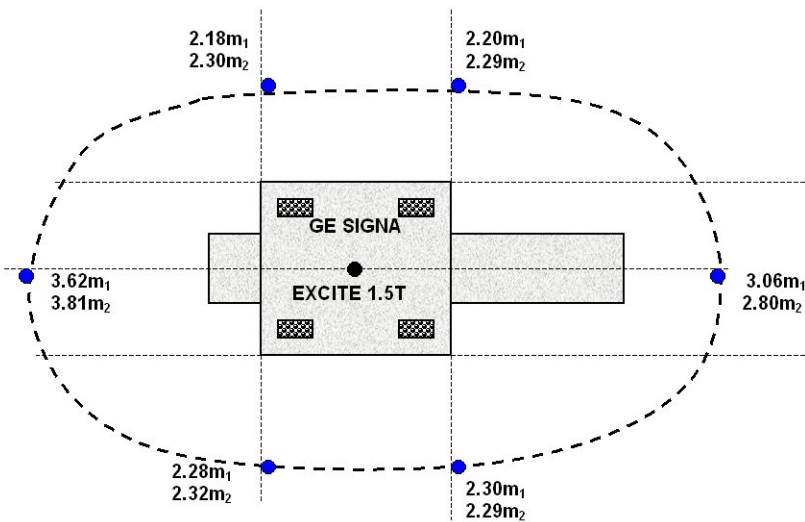
Figure B- 1: The 0.5 mT isocontour around GE Signa Excite Echospeed 1.5T Scanner  
 Table 1 below shows the average repeatability of the isocontour measurements.

Field intensity (mT)	1st Reading (R1) in m	2nd Reading (R2) in m	% difference between R2 and M
0.50	3.06	2.80	8.4%
0.50	3.62	3.81	4.9%
0.50	2.30	2.29	0.4%
0.50	2.28	2.32	1.7%
0.50	2.18	2.30	5.2%
0.50	2.20	2.29	3.9%
		AVERAGE	4.1%
